**Re: Western Wood Products, Inc., Raton, Colfax County, New Mexico; Unpermitted MSGP;
SIC 2448; Compliance Evaluation Inspection; NPDES Tracking No. NMU001935; July 20,
2017**

NPDES Compliance Inspection Report

Western Wood Products, Inc.
Compliance Evaluation Inspection
NPDES Tracking No. NMU001935
July 20, 2017

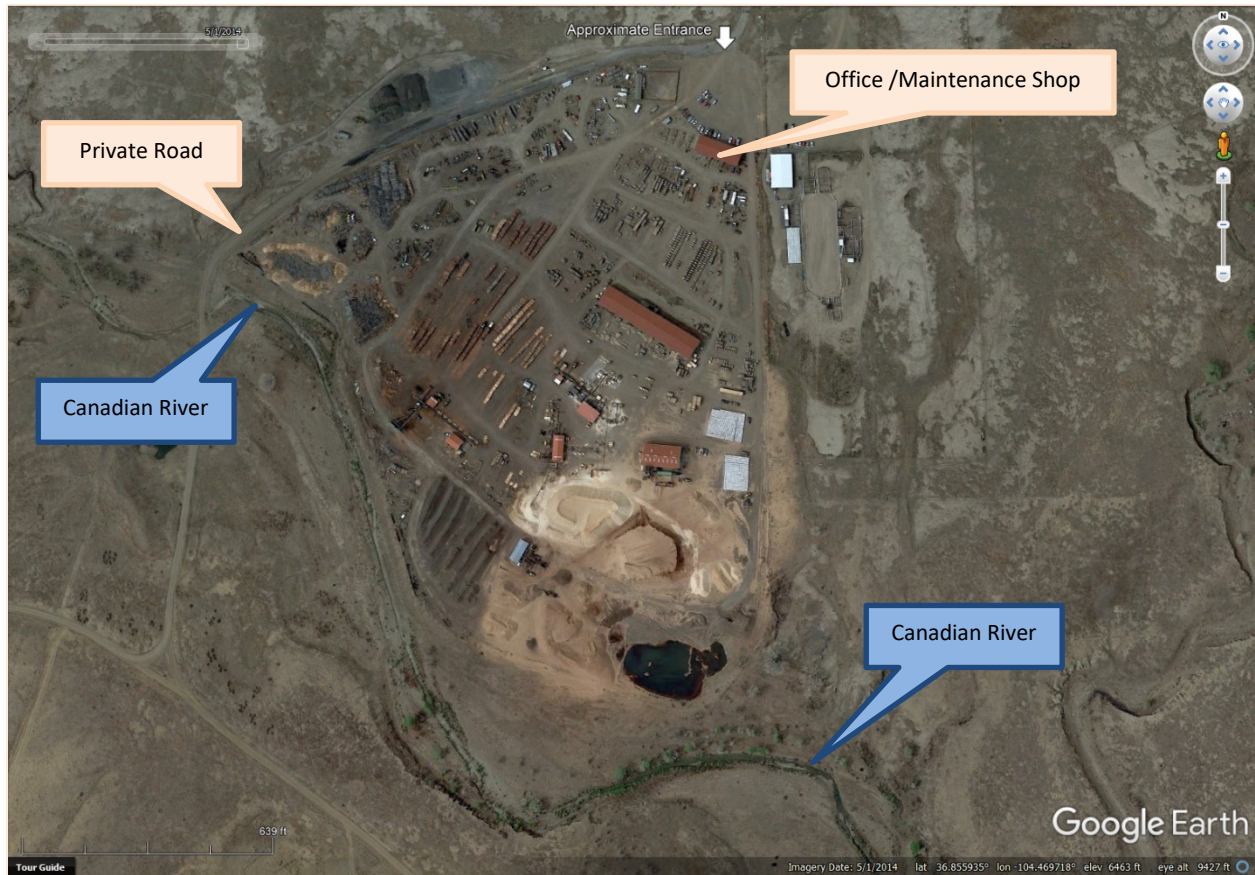
Figure 2 – Site and Adjacent Area (Google Earth Imagery Date 05/01/2014)

Storm water flow from the industrial activity manufacturing, processing and materials storage areas at the facility appeared to be to the south-southeast based on drainage ditches and shallow erosional rills in the south-southeast corner of the site. A vegetated stormwater ditch was observed along the eastern property boundary and water collects in an excavation in the southeast corner of the site. Flow from a City broken potable water line was observed near, but appeared to infiltrate before reaching, the ditch. Stormwater runoff had collected along the eastern property boundary and water existed in an excavation in the southeast corner of the site. Constructed berms were observed along portions of the southern property boundary. No stormwater or non-stormwater discharges from the facility were observed on the day of this CEI.

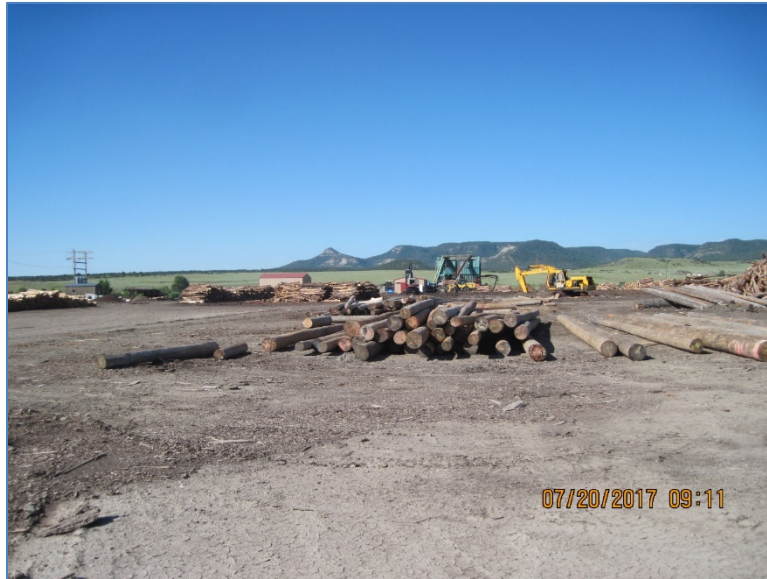
NMED/SWQB Official Photograph Log Photo # 1		
Photographer: Erin S. Trujillo	Date: 07/20/2017	Time: 0911 hours
City/County: South of Raton, New Mexico / Colfax County		State: New Mexico
Location: Western Wood Products, Inc., 181 State Hwy 555, Raton, New Mexico 87740		
Subject: Example of timber storage and heavy equipment at site.

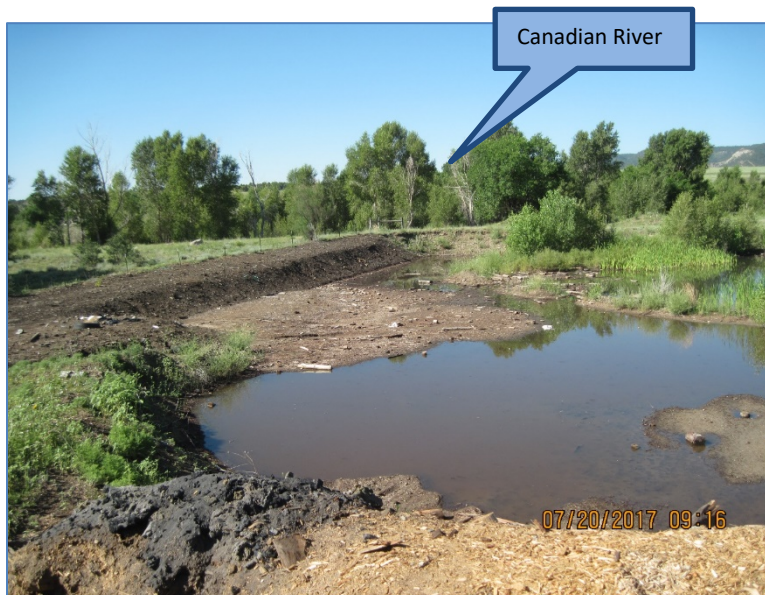
NMED/SWQB Official Photograph Log Photo # 2		
Photographer: Erin S. Trujillo	Date: 07/20/2017	Time: 0916 hours
City/County: South of Raton, New Mexico / Colfax County		State: New Mexico
Location: Western Wood Products, Inc., 181 State Hwy 555, Raton, New Mexico 87740		
Subject: Looking south, water existed in excavation near southeast corner of property.

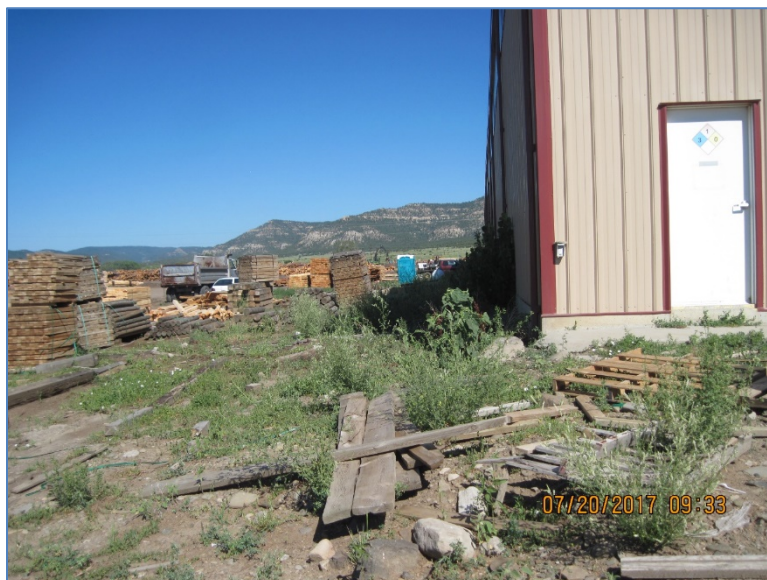
- The facility had outside vehicle and equipment fueling, storage of raw material, intermediate products, final product, and by-products and material handling that would come into contact with stormwater. Other potential sources of pollutants included portable toilets at various locations. Oily residue on containers and staining of the surface soils existed around the fueling and waste oil storage area was observed. Housekeeping at the site did not appear orderly with numerous unused product buckets, drums and broken pallets.

NMED/SWQB Official Photograph Log Photo # 4		
Photographer: Erin S. Trujillo	Date: 07/20/2017	Time: 0933 hours
City/County: South of Raton, New Mexico / Colfax County		State: New Mexico
Location: Western Wood Products, Inc., 181 State Hwy 555, Raton, New Mexico 87740		
Subject: Looking west, examples of product storage, miscellaneous debris and portable toilet on site.

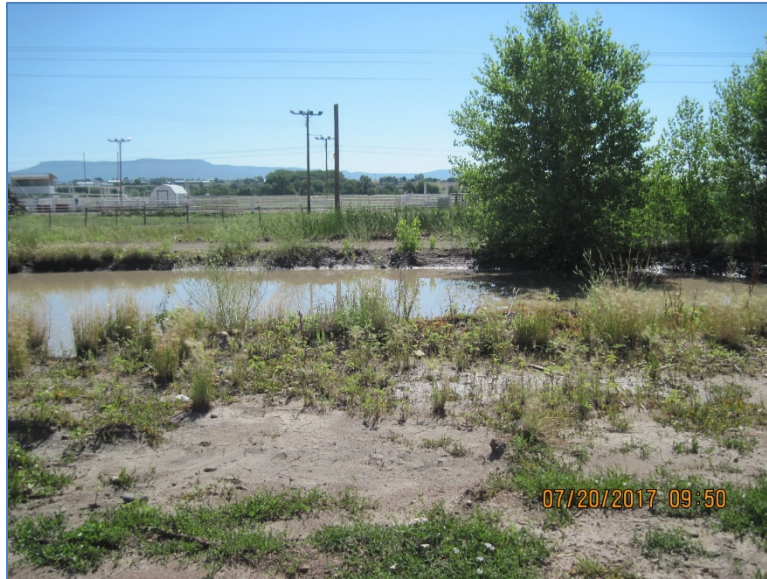
NMED/SWQB Official Photograph Log Photo # 5		
Photographer: Erin S. Trujillo	Date: 07/20/2017	Time: 0950 hours
City/County: South of Raton, New Mexico / Colfax County		State: New Mexico
Location: Western Wood Products, Inc., 181 State Hwy 555, Raton, New Mexico 87740		
Subject: Standing water along eastern property boundary.

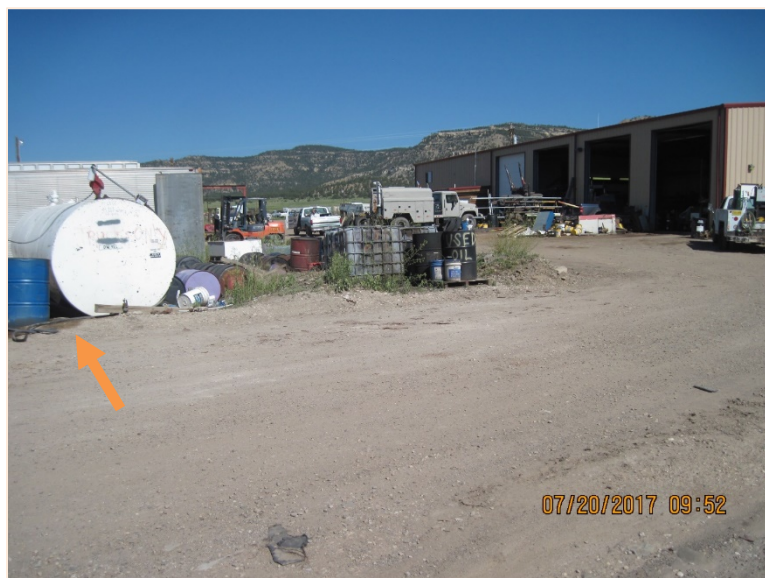
NMED/SWQB Official Photograph Log Photo # 6		
Photographer: Erin S. Trujillo	Date: 07/20/2017	Time: 0952 hours
City/County: South of Raton, New Mexico / Colfax County		State: New Mexico
Location: Western Wood Products, Inc., 181 State Hwy 555, Raton, New Mexico 87740		
Subject: Drum, fuel and waste oil storage area. Arrow points to staining of surface soils and drum at fuel tank.

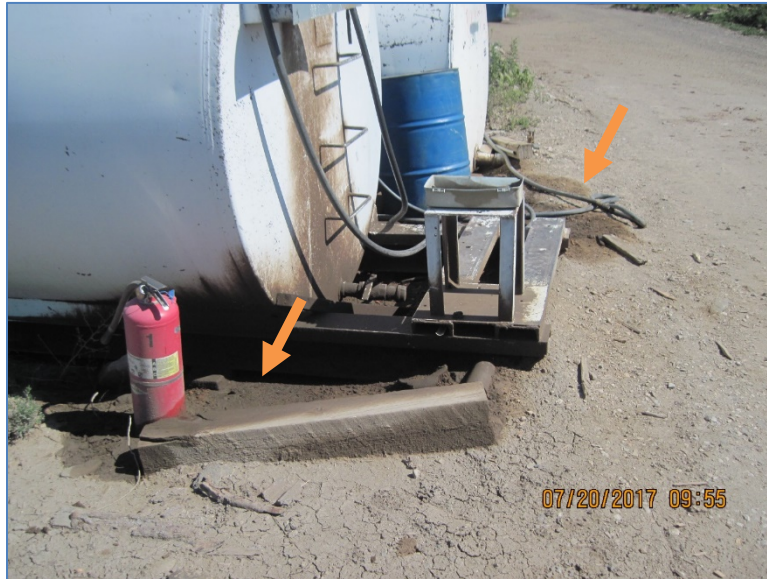
NMED/SWQB Official Photograph Log Photo # 7		
Photographer: Erin S. Trujillo	Date: 07/20/2017	Time: 0955 hours
City/County: South of Raton, New Mexico / Colfax County		State: New Mexico
Location: Western Wood Products, Inc., 181 State Hwy 555, Raton, New Mexico 87740		
Subject: Arrows point to examples of stained soil at fueling area shown in previous photo #6.

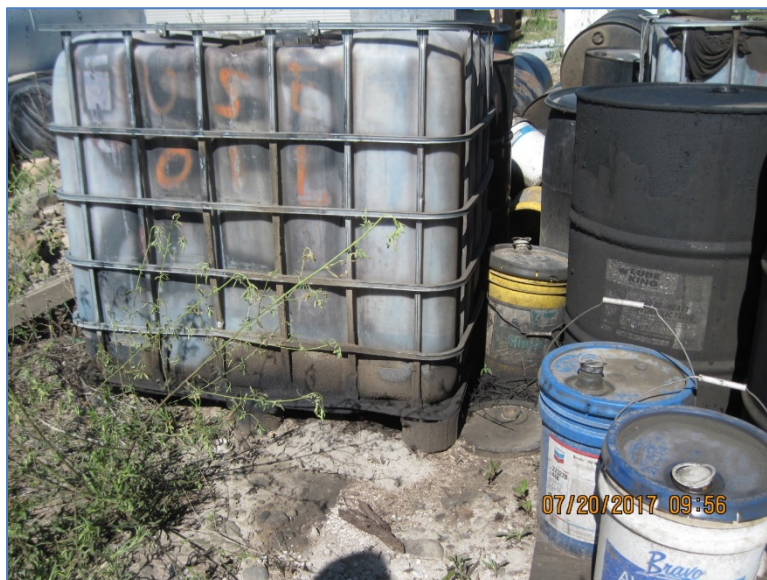
NMED/SWQB Official Photograph Log Photo # 8		
Photographer: Erin S. Trujillo	Date: 07/20/2017	Time: 0956 hours
City/County: South of Raton, New Mexico / Colfax County		State: New Mexico
Location: Western Wood Products, Inc., 181 State Hwy 555, Raton, New Mexico 87740		
Subject: Arrows point to oily residue on containers and stained soils at used oil storage area shown in previous photo #6.

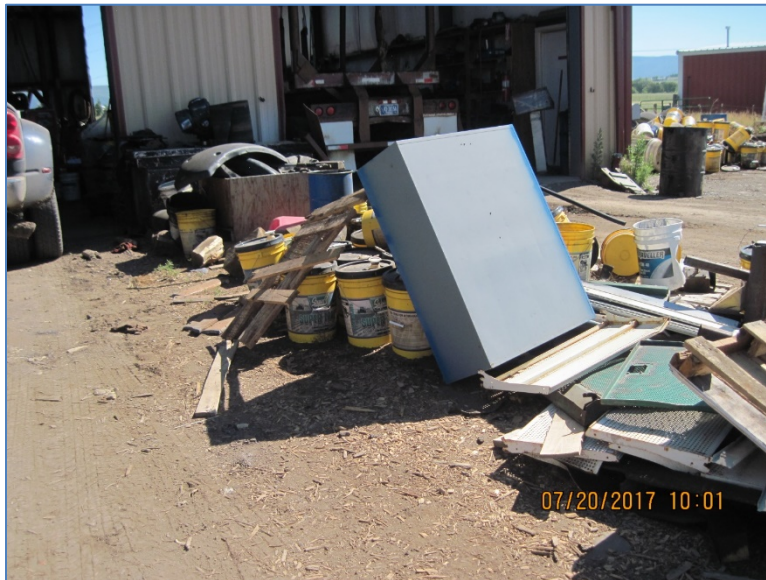
NMED/SWQB Official Photograph Log Photo # 9		
Photographer: Erin S. Trujillo	Date: 07/20/2017	Time: 1001 hours
City/County: South of Raton, New Mexico / Colfax County		State: New Mexico
Location: Western Wood Products, Inc., 181 State Hwy 555, Raton, New Mexico 87740		
Subject: Examples of materials and product bucket storage at maintenance shop shown in previous photo #6.
